**THE CALIFORNIA EARTHQUAKE OF APRIL 18, 1906**

**REPORT**

**STATE EARTHQUAKE INVESTIGATION COMMISSION**

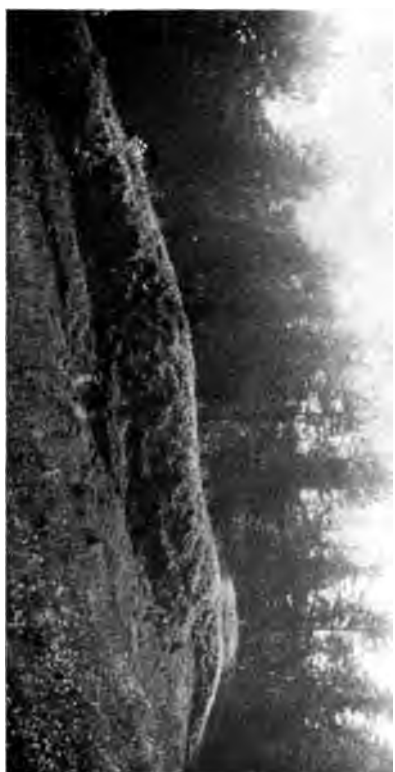
D. Accentuation of old fault-scarp by new fault. Near Fort Ross. F. E. M.

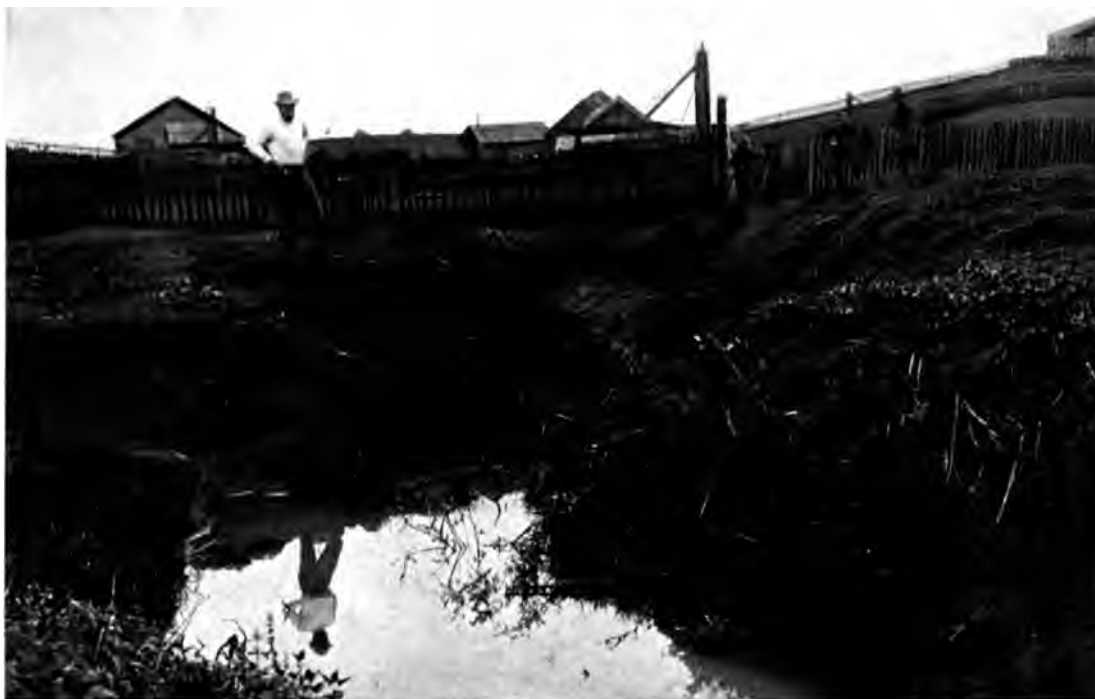
A. Offset of stream trench by the fault and ponding of water by the fault-scarp. Doda's ranch, a mile southeast of Fort Ross. A. C. L.

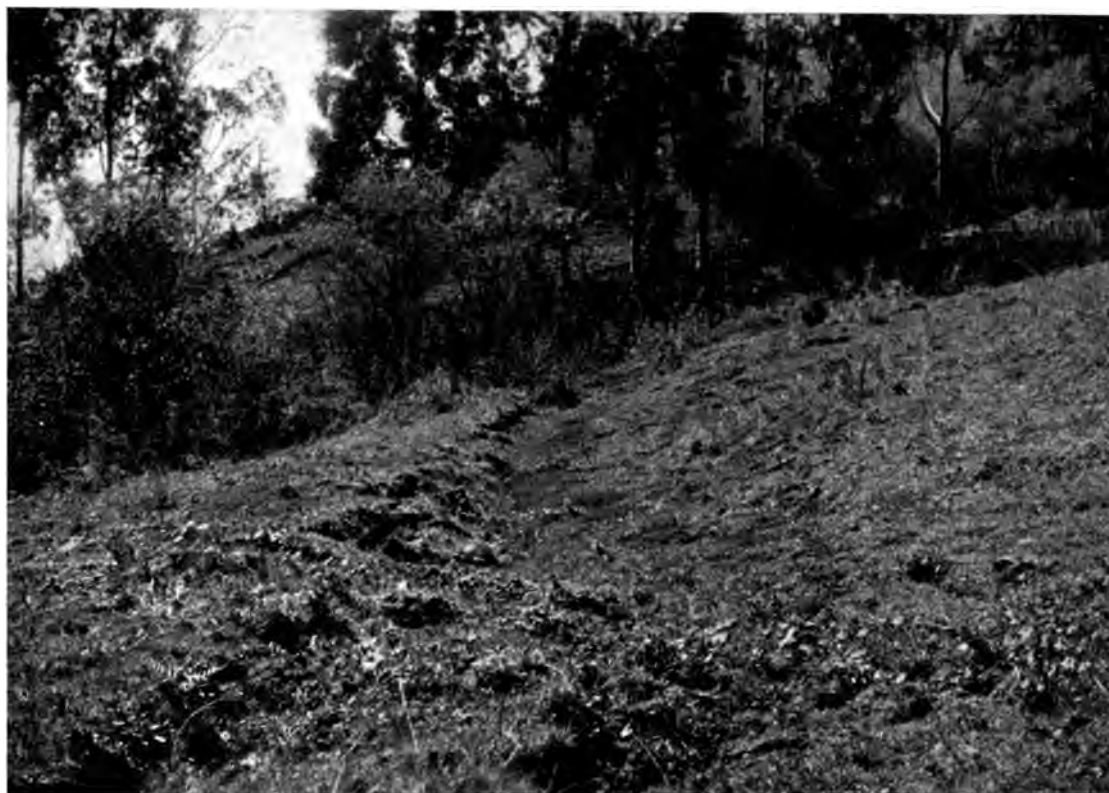
B. The fault-trace a mile northwest of Bolinas Lagoon, looking southwest. Illustrates the ridge phase. G. K. G.

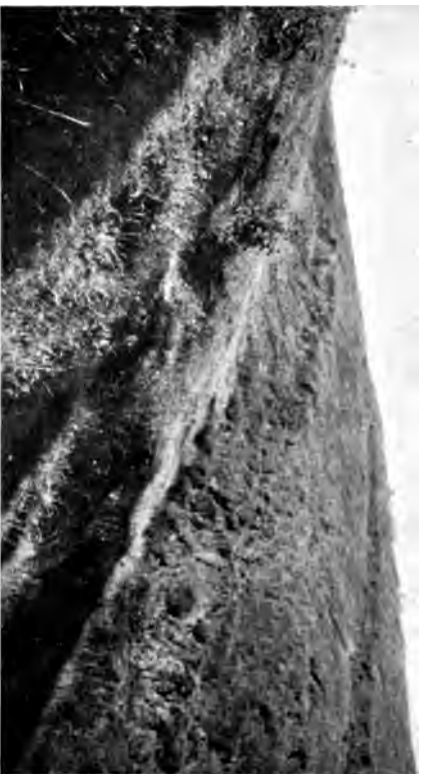
A. Fault-trace in old depression marked by scarp 3  $\pm$  feet high, with auxiliary scarp above. Dede's ranch, a mile southeast of Fort Ross. Looking southwest. F. E. M.

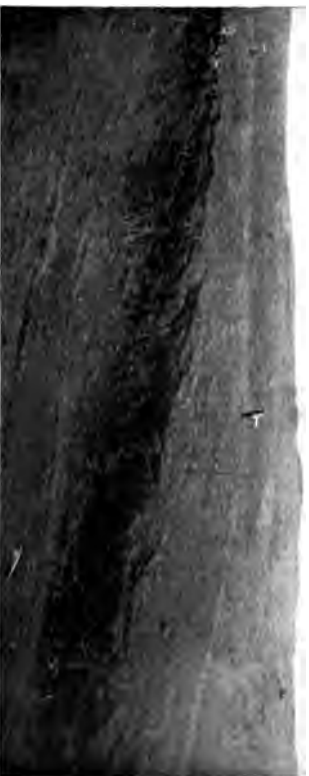
B. Fault-trace marked by scarp 3  $\pm$  feet high on west side. Southeast of Fort Ross, looking southwest. F. E. M.

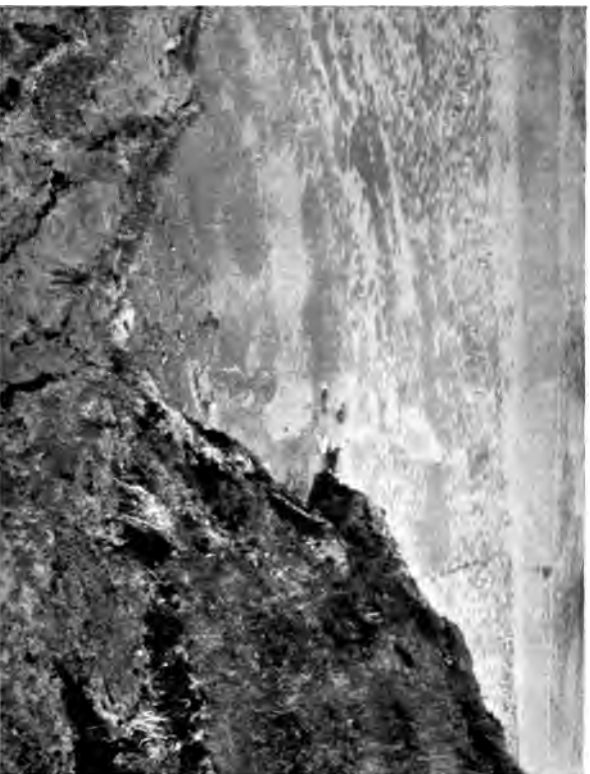
C. Fault-trace extending from cliff in foreground across tidal flats of Tomales Bay, near its mouth. R. S. H.

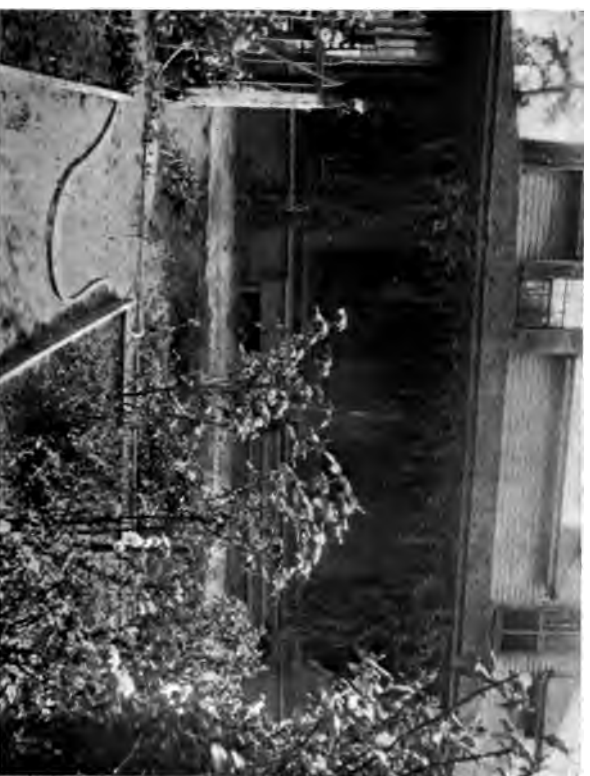
D. Fault-trace between garden and house, Skinner's ranch, near Olema. Before earthquake center lines of path and steps were coincident; afterwards offset was 16 feet 9 inches.

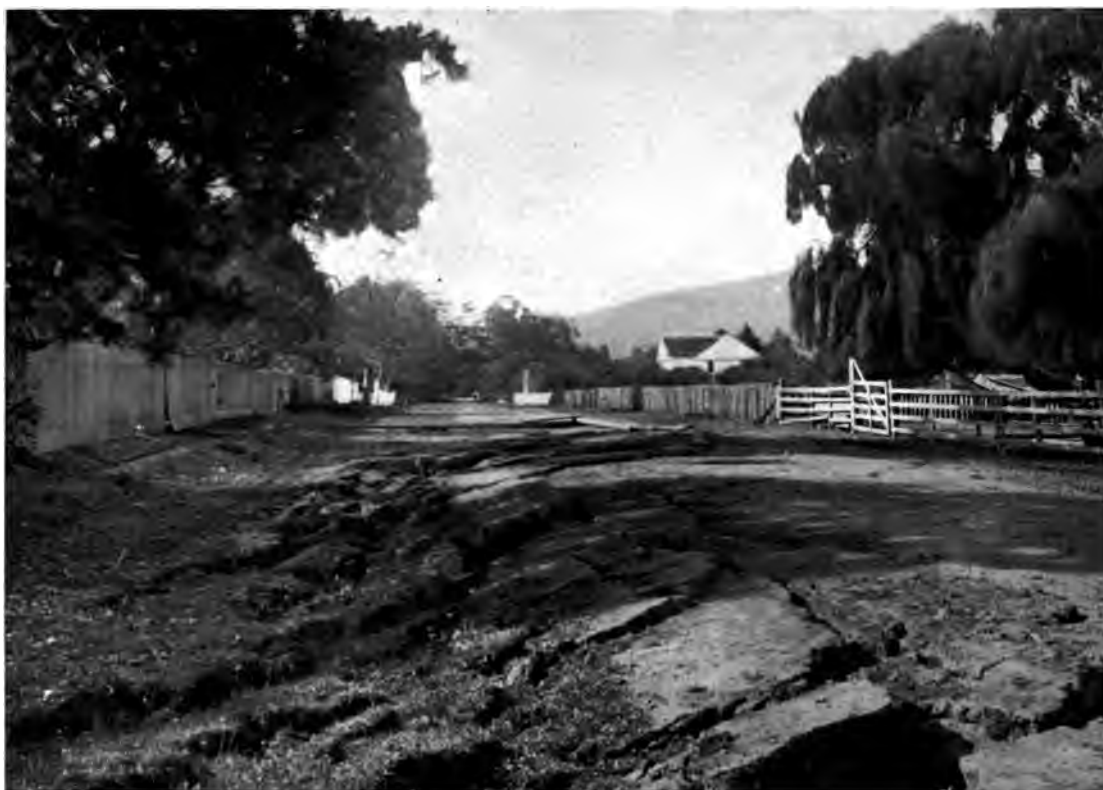
A. Branch of fault-trace in north part of Bolinas. Looking north-northwest. Illustrates diagonal cracks. G. K. G.

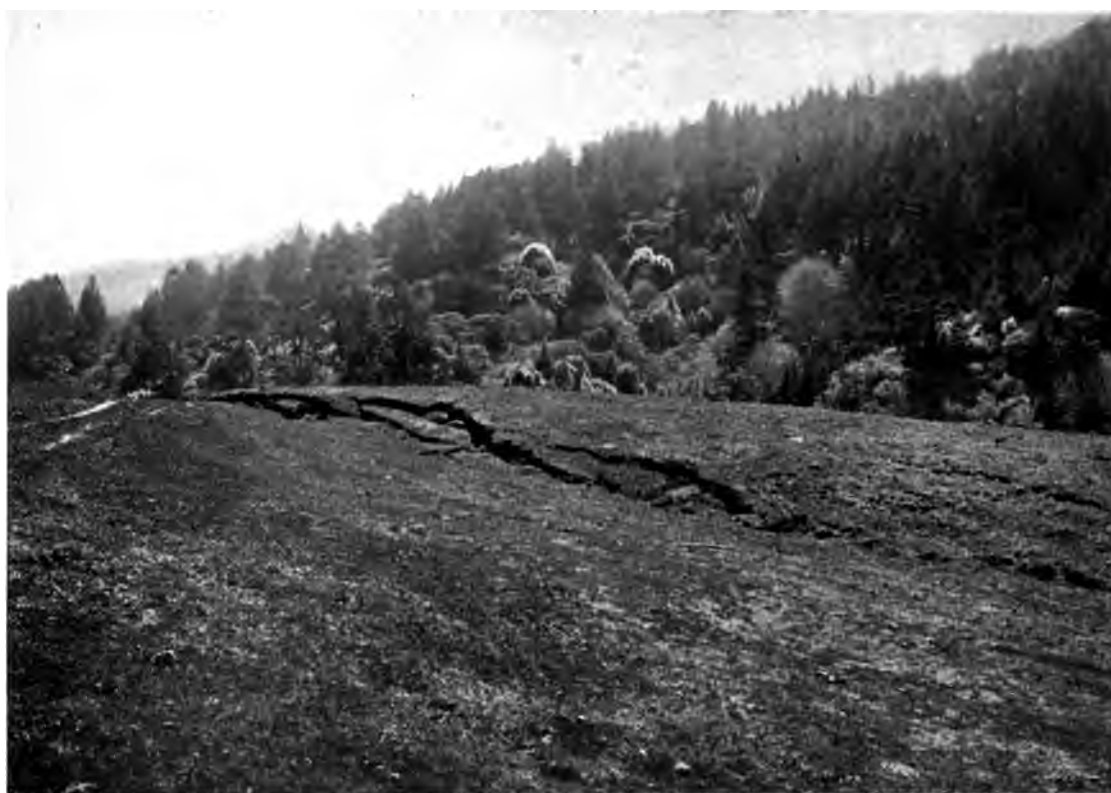
B. Branch of fault-trace, near Bondietti's ranch. Looking south. Illustrates diagonal cracks. G. K. G.

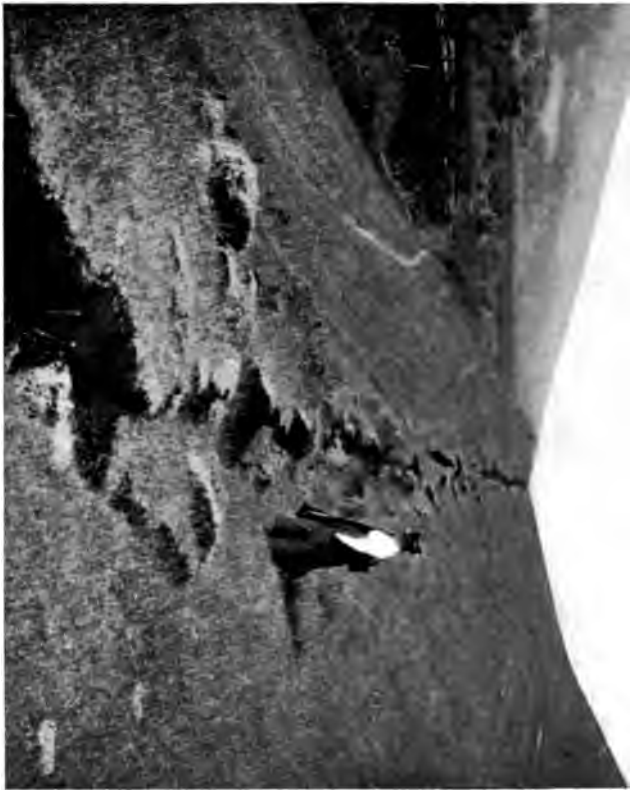
For considerably more than half its length the surface expression is a ridge from 3 to 10 feet wide and ranging from a few inches to about 1.5 feet high. (See plates 37B and 40A.) The ground constituting the ridge is in fragments, loosely aggregated, so that there are considerable voids. Where pasture lands are crossed the turf is torn into blocks, and these, in conjunction with the cracks which separate them, make up a pattern. This pattern is always irregular and sometimes gives no evidence of system, but usually its lines have a dominant direction, traversing the ridge obliquely, the northern ends of the cracks pointing toward the eastern boundary of the ridge, and the southern ends toward the western boundary. The cracks have resulted from stresses connected with the horizontal faulting, in which the southwest block moved northwest with reference to the northeast block. (See plate 39.)

A. Fault-trace a mile northwest of Olema. Looking northwest. Illustrates ridge phase. G. K. G.

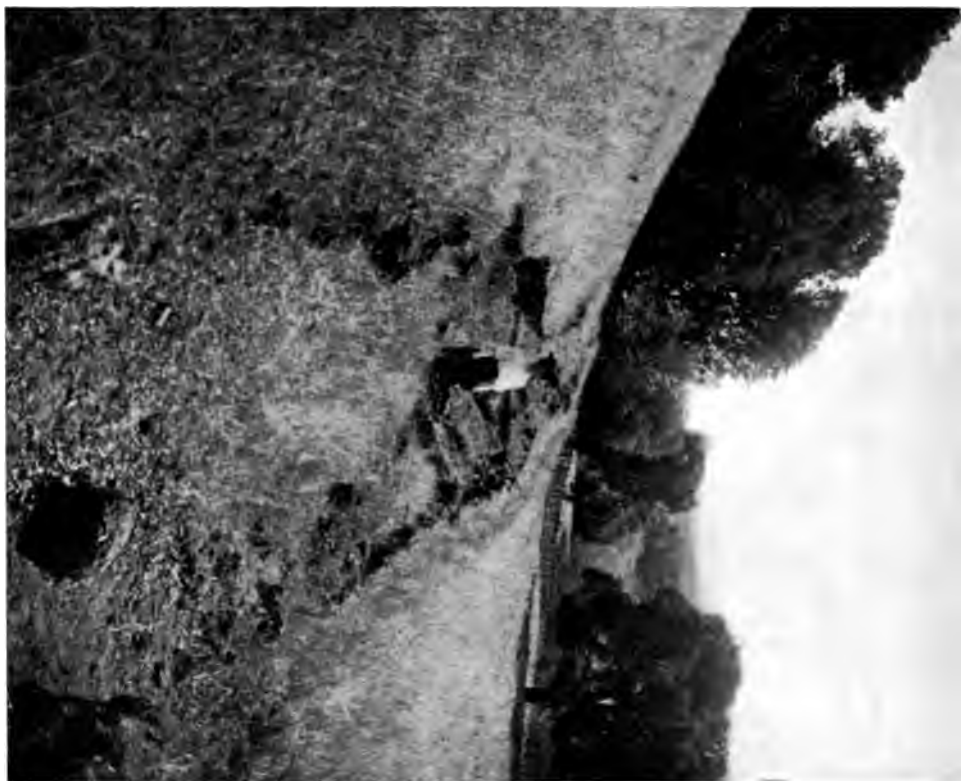
In other places, and usually for short distances, the surface expression is a shallow trench (plates 40B and 46B), with ragged vertical sides from 2 to 5 or 6 feet apart, and occupied by loosely aggregated fragments of the ground, the pattern of the fragments and interstices being similar to that observed in the case of the ridges. This phase suggests that just below the surface the fault may be somewhat open, so that there has been an opportunity for fragments to drop into it.

B. The fault-trace west of Olema. Looking southeast. Illustrates the trench phase. G. K. G.

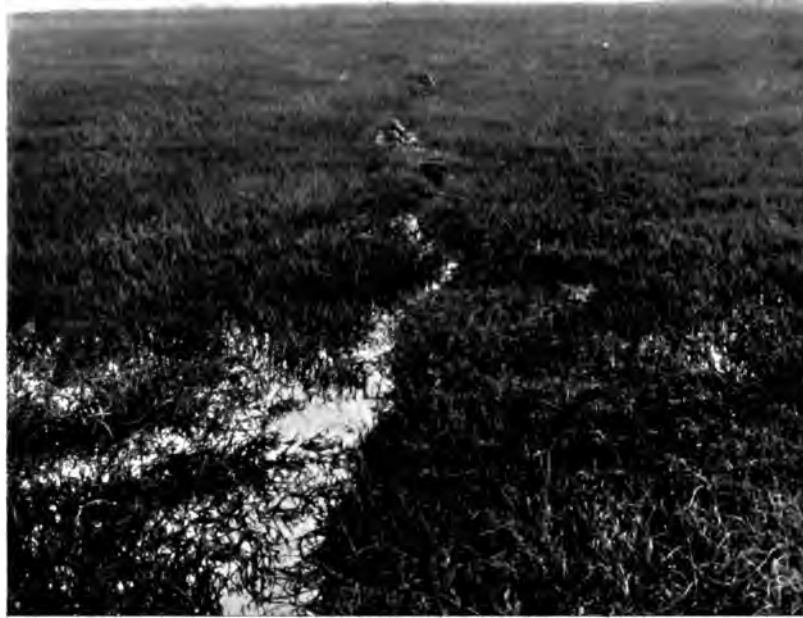
A. Looking southeast on Pepper Island. In the foreground the fault-trace is central. It trends toward the distant +. G. K. G.

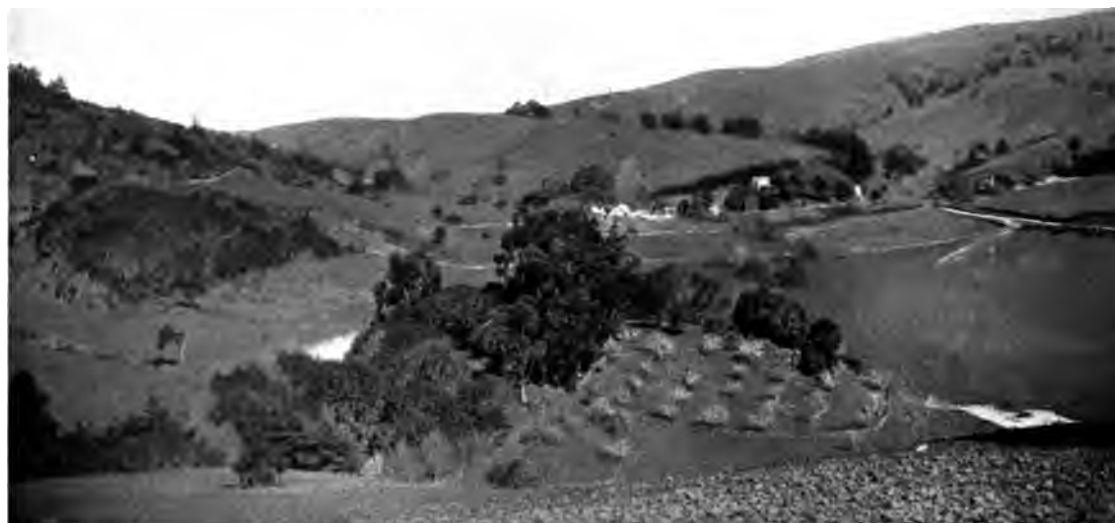
B. Looking north from hill west of Woodville. From buildings (Strain ranch) a large rift ridge runs northwest between 2 fault-sags. The western sag is followed by Pine Gulch Creek. Fault-trace runs from right of pond in foreground to left of buildings and follows sag for a mile, gradually crossing it. G. K. G.

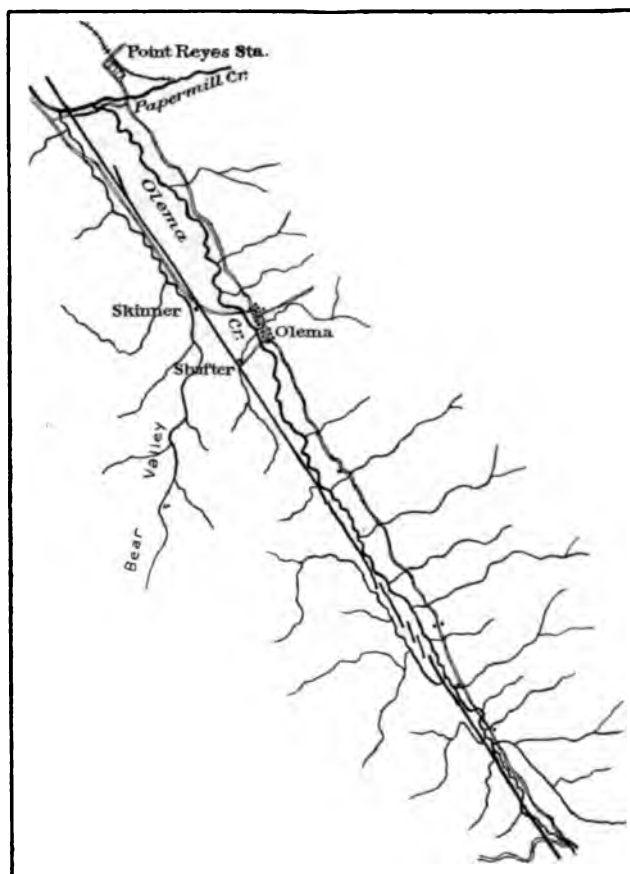
FIG. 16. — Map of fault-trace from Papermill Creek southward. Scale, 1:62,500.

of the fault-trace in this region and thence north to Papermill Creek is shown by fig. 16, a compilation based on data from several sources, including a few original measurements.

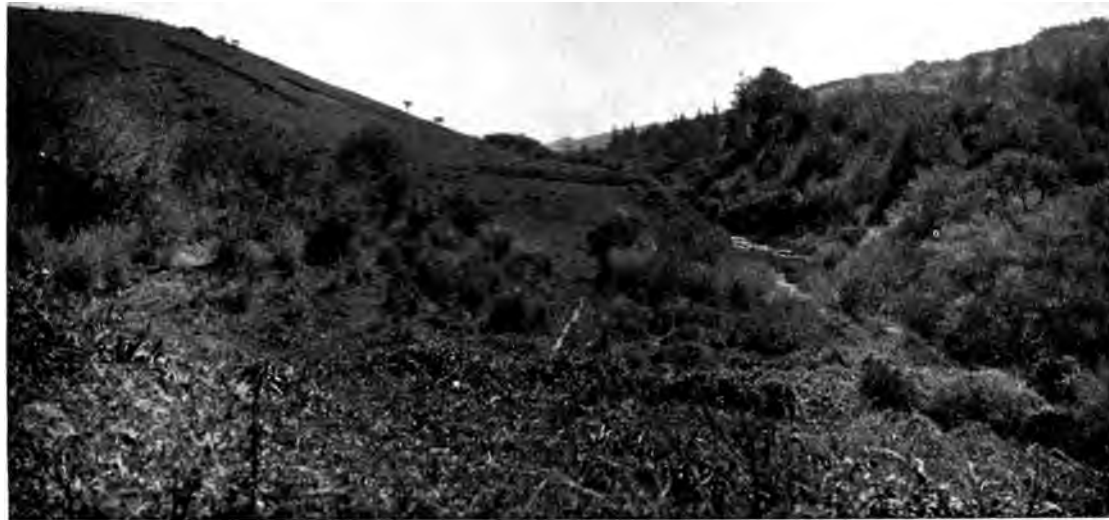
A. Sag followed by fault-trace a mile north of Strain ranch. Looking southeast. Trace, concealed by bushes, runs near ponds. G. K. G.

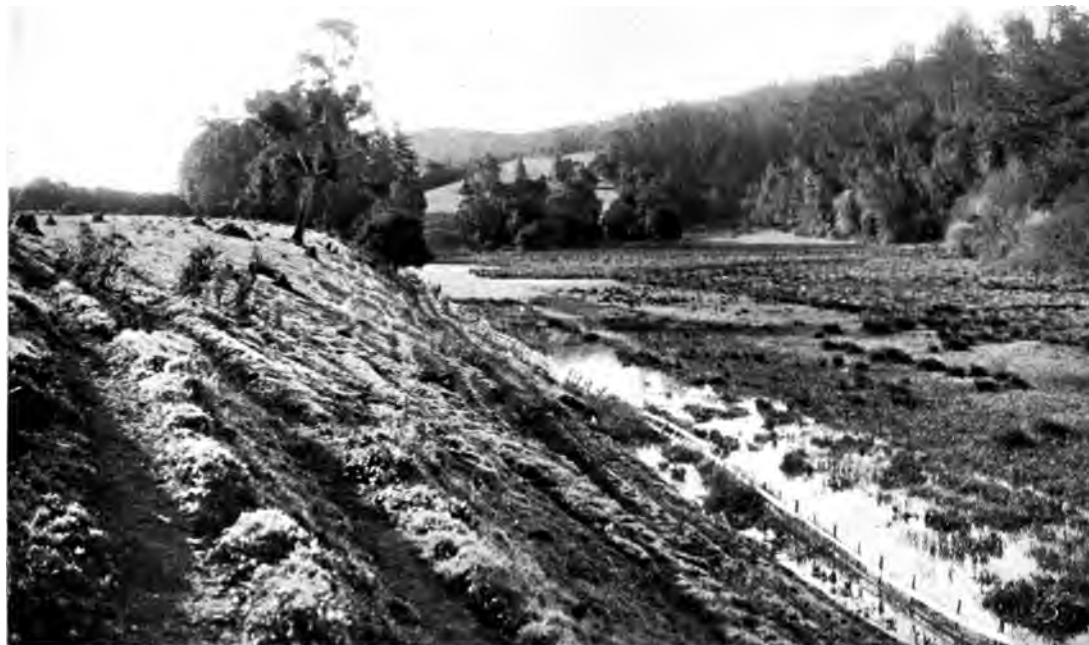
A mile south of the village of Olema the trace enters a sag which is followed continuously for nearly 3 miles. At first the sag is narrow and is attached to the northeast slope of a ridge, but approaching the Shafter place the ridge crest sinks and a broad sag replaces it in the line of trend. (Plate 42B.) In following the eastern edge of this sag from the Shafter place to Papermill Creek the fault-trace also follows the western base of a line of hills. The hills are peculiar in that their western, or more strictly southwestern, base, being determined by faulting, is nearly straight (plate 42B); while their northeastern base, modified by the erosive action of Olema Creek, is scalloped. In this region the ridge phase of the fault-trace dominates, being occasionally replaced by the trench phase. (See

B. Looking southeast from point near Shafter's ranch, Olema. Fault-trace follows base of hill and includes water-filled depression. G. K. G.

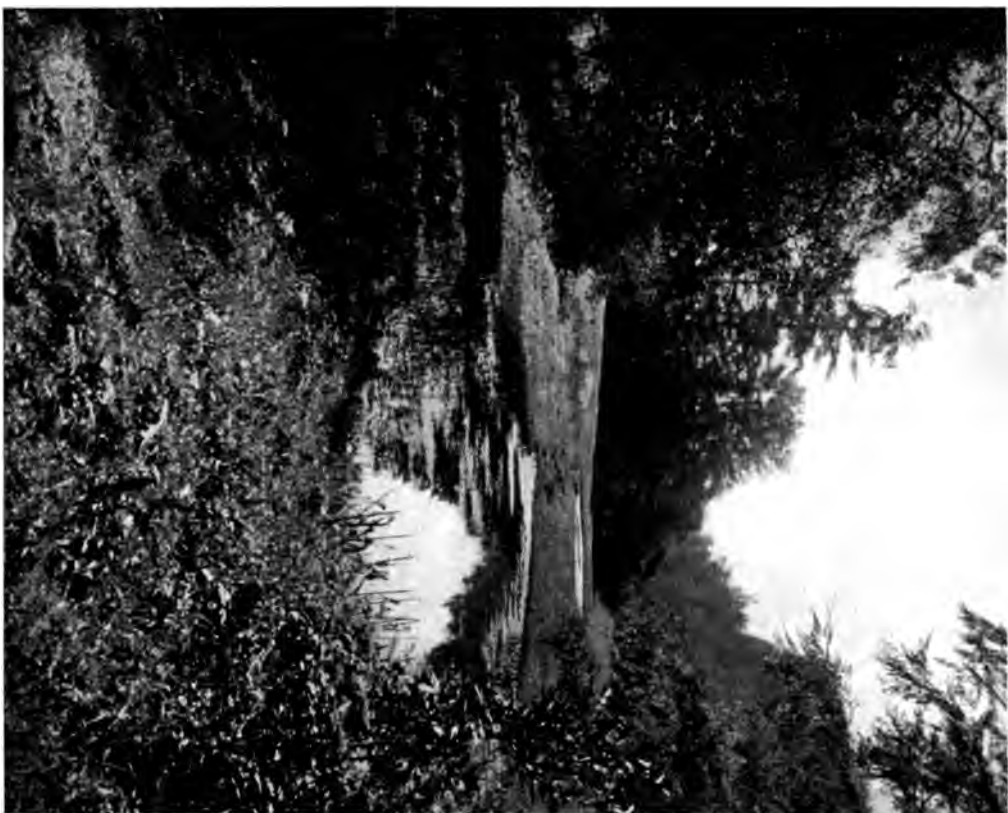
A. Fault-trace 1.5 miles south of Olema. Looking southeast. Trace touches both ponds, being best seen between them. G. K. G.

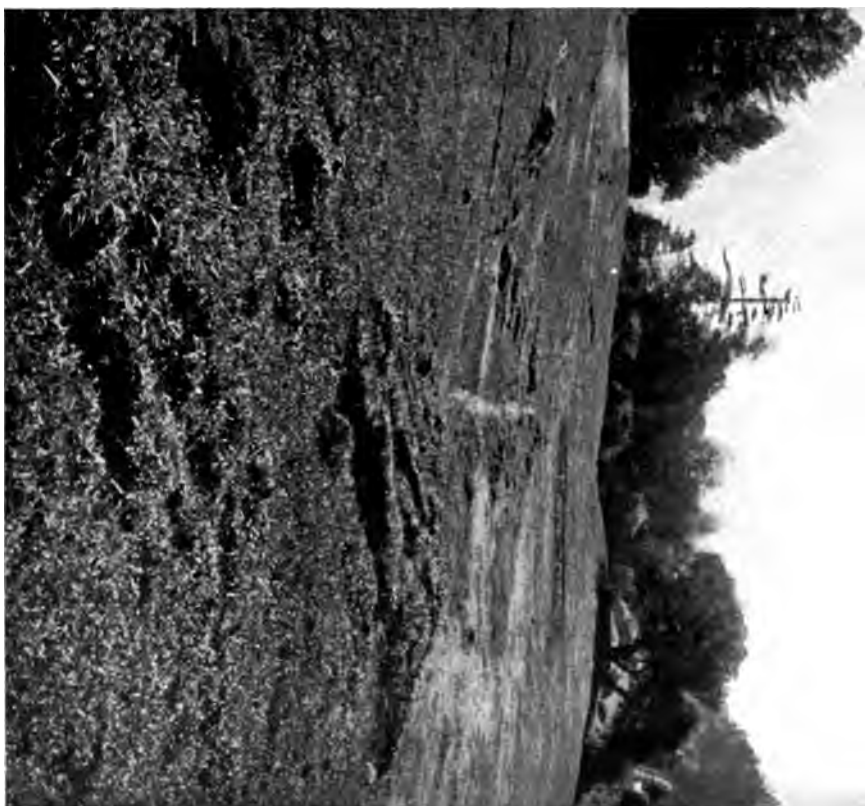
B. Looking southeast across hill-top a mile south of Olema. Shallow sag gives hill double crest and makes a pond basin. The fault-trace, both in foreground and beyond, is divided in several branches. G. K. G.

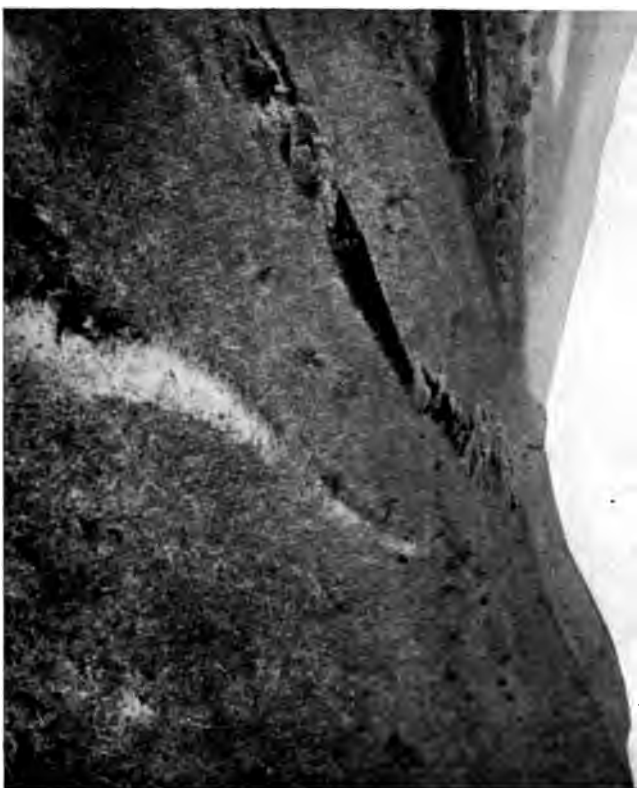
A. Fault-trace a mile northwest of Olema. Looking northwest. G. K. G.

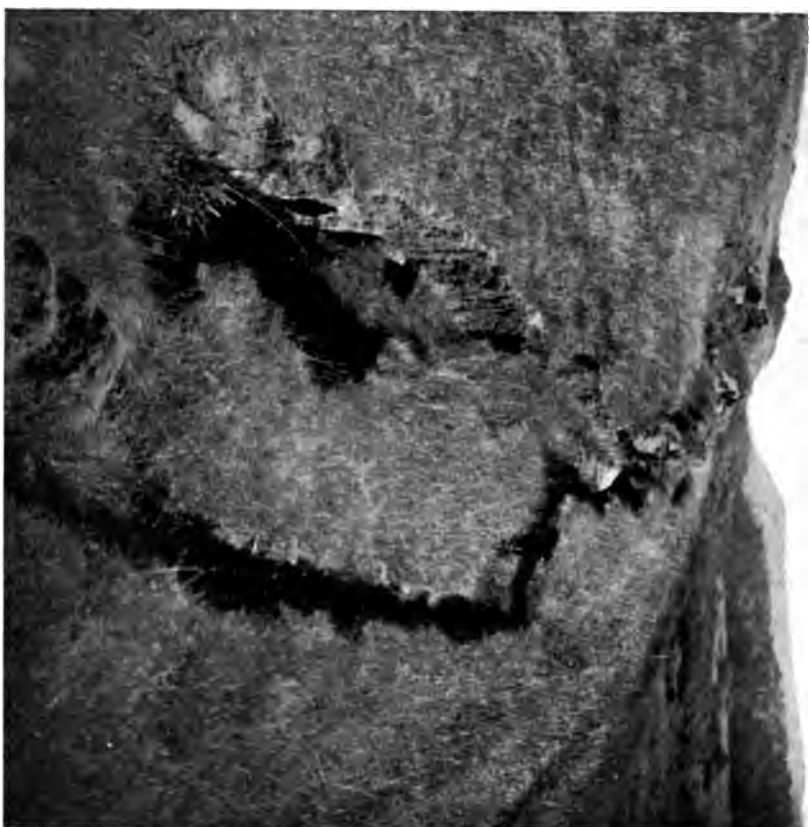
B. Fault-trace a mile northwest of Olema. Looking southeast. G. K. G.

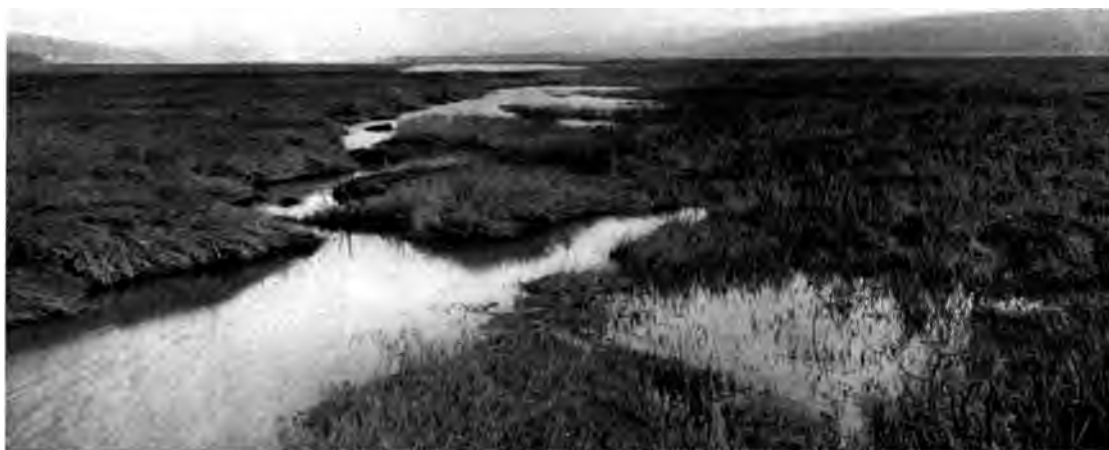
A. Fault-trace on Papermill delta. Looking northwest. The water lanes are largely at right of main line of fracture. G. K. G.

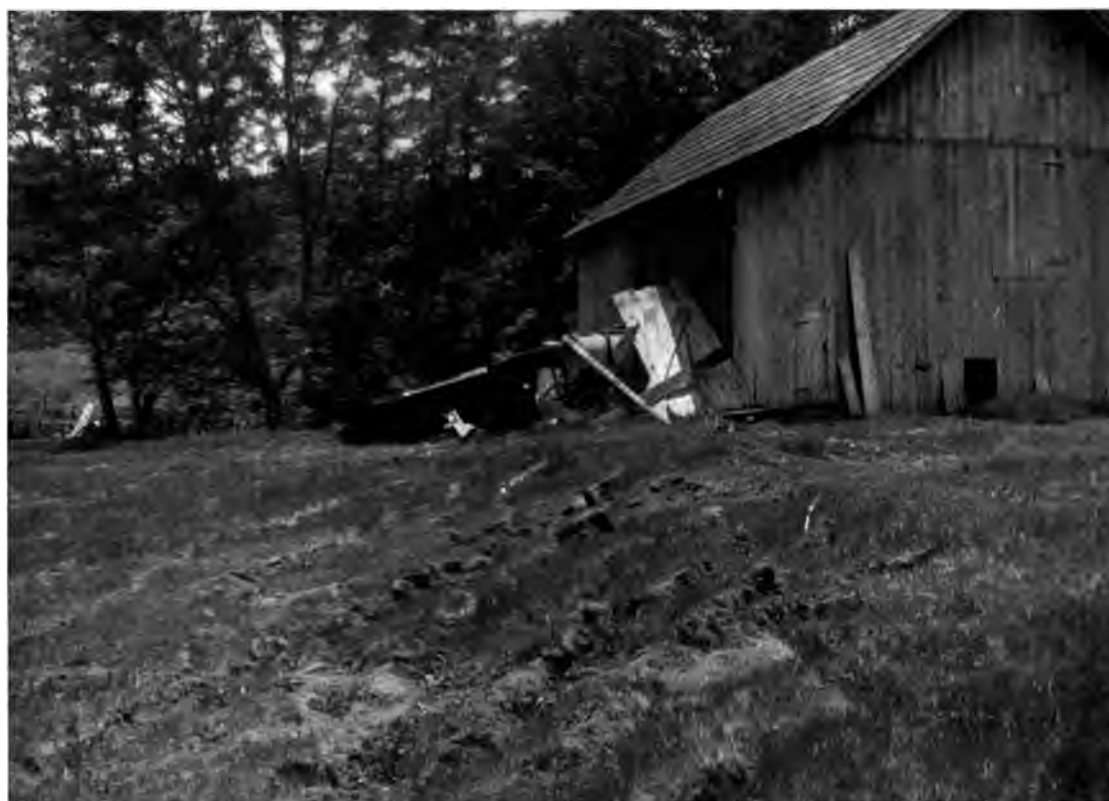
B. Branch of fault-trace in "Second Valley," at Inverness. Looking south-southeast. G. K. G.

plate 44.) A few minor branches were seen on the east side. The pool or lane of water shown in plate 42B is about 2 feet deep. Mr. Shafter states that the ground here was dry and under cultivation before the earthquake. Shortly after the shock he noticed that the current of a creek close by was reversed.

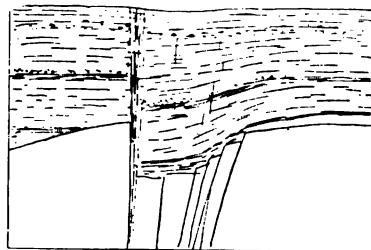
FIG. 17.—Hypothetic section of fault under Papermill Delta.

The general relation of the sag to the fault-trace is shown in fig. 17. It occurs only on the northeast side, but is so persistent that, from a commanding position, the fault can be traced out by means of the water lanes. The depression will probably average more than 50 feet wide, but it eludes measurement because it fades out gradually on the side away from the fault. The greatest noted depth is 17 inches, but the average is probably less than a foot. In attempting to interpret this feature I assume that beneath the smooth plane of the delta, and buried by its soft deposits, is a variegated topography of the rift type; and the hypothesis I advance is that the new-made sag on the delta plain is the surface echo of a fault-sag of the buried topography which was made deeper by the event of April, 1906. It has already been pointed out (page 67) that the sags of the Rift which were touched by the new fault were apparently deepened; and if the true explanation of the delta-sag has been suggested, we have in that feature an indication that the deepening was not only apparent but real.

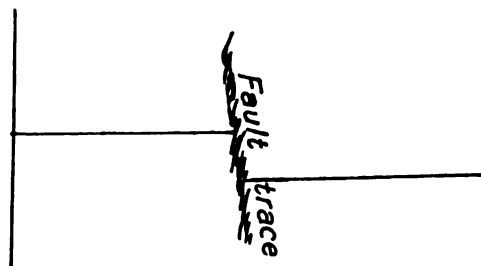
FIG. 19.—Dislocated fence on farm of S. S. Southworth, near Woodville.

fault on the southwest side follow a gently curving line. The indication is that about three-fourths of the whole displacement occurred on the main plane of the fracture, and the remainder was diffused thru the ground adjoining on the southwest. A closely related condition exists at the southern limit of the same field, where the fault-trace intersects a fence at right angles. The offset is 7 feet 8 inches, and this is accompanied by a change of direction. (Fig. 19.) Unfortunately the fence is too short to indicate in full the changes of the ground, but the suggestion is that in addition to the visible offset, there is a diffused shear affecting the ground southwest of the fault so that the entire displacement is greater than the amount shown by the offset. Assuming the fence to have been originally straight, the total displacement here was more than 12 feet.

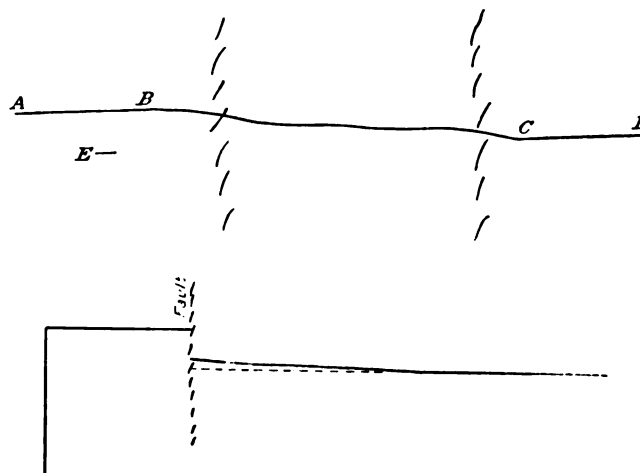
On Mr. E. R. Strain's place, west of Woodville, measurements are afforded by the disturbance of two fences. The more southerly (fig. 20) is crost by two visible branches of the fault, and there is probably more or less diffused shear in the intervening ground. The fence, said by Mr. Strain to have been originally straight, has now two straight portions, *AB* and *CD*, and the distance from *AB* to *E*, on the line of *CD* produced, is 15 feet. The second fence, standing a little farther north, is intersected by one visible fault-trace, the continuation of the trace which crosses the first fence near *B*. On this line the fence is broken and offset 8.5 feet. The remnant of fence to the southwest is straight, but swerves in approaching the fault-trace, as indicated in fig. 21 and in plate 49A. The total displacement of the straight portions of the fence is about 11 feet.

FIGS. 20 and 21.—Dislocated fences on farm of E. R. Strain, near Woodville.

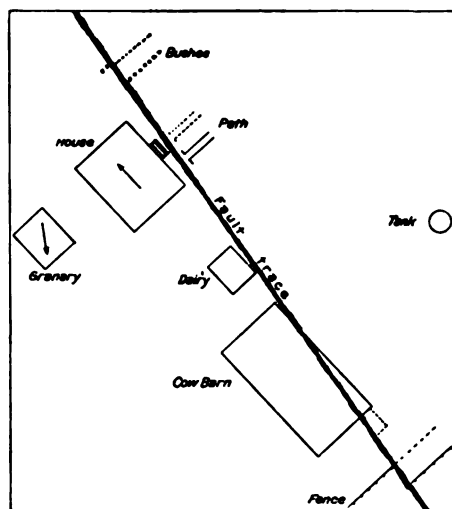
Eight miles farther north, at Mr. W. D. Skinner's place, near Olema, the entire fault is apparently concentrated in a single narrow zone, and the several measurements made are in close accord. The fence south of his barn (fig. 22) was offset 15.5 feet. The barn, beneath which the fault-trace past, remained attached to the foundation on the southwest side, but was broken from it on the northwest side and dragged 16 feet. A path in the garden, originally opposite steps leading to the porch, was offset 15 feet. (Plate 38D.) A row of raspberry bushes in the garden was offset 14.5 feet. The mean of these four measurements is 15.25 feet, and their range is 1.5 feet.

FIG. 22. — Plan of Skinner premises, showing character of displacements measured. The broken lines show positions of bushes, path, and fence before earthquake in relation to objects west of fault; also position before earthquake of corner of barn with reference to ground east of fault.

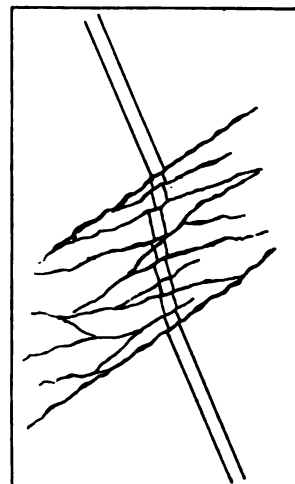
The road running southwest from Point Reyes Station and crossing the valley at the head of Papermill Creek delta was offset 20 feet. (Fig. 23 and plate 47B.) As the fault-trace at this point was between 50 and 60 feet wide, and as the embankment of the road for that distance was broken into several pieces, it was not possible to make certain that the dis severed remnants of the road had originally been in exact alinement. It is probable, however, that the road was approximately straight before the earthquake, and that the exceptionally great offset at this point is to be explained as the result of a horizontal shifting of the surface materials. The embankment of the road rested on marshy ground so soft that a portion of the embankment sank into it, and material of this character was in other localities demonstrably shifted.

FIG. 23. — Dislocated road shown in plate 47B. Parallel lines represent wheel tracks. Ramifying lines indicate cracks of fault-zone.

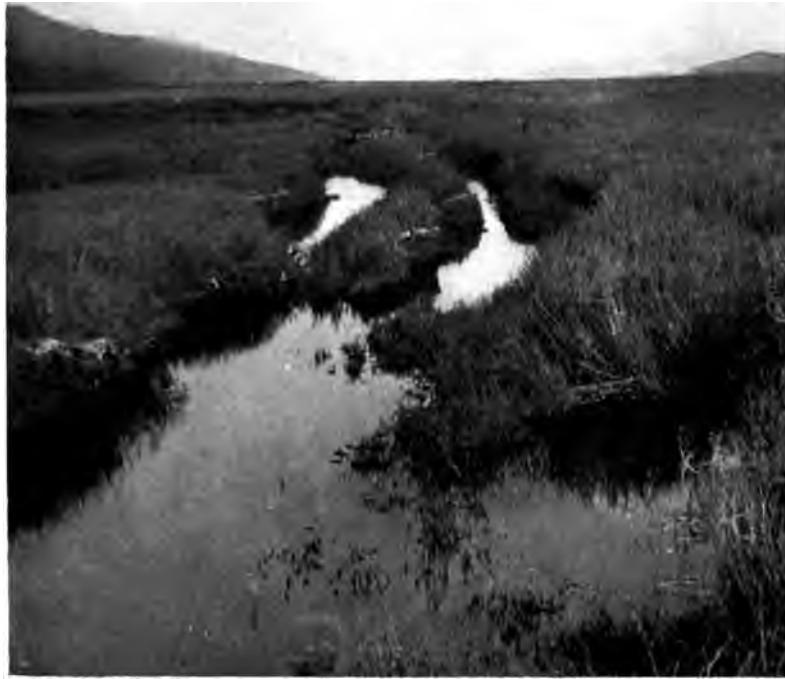
A. Fault-trace on Papermill delta. Looking northwest. G. K. G.

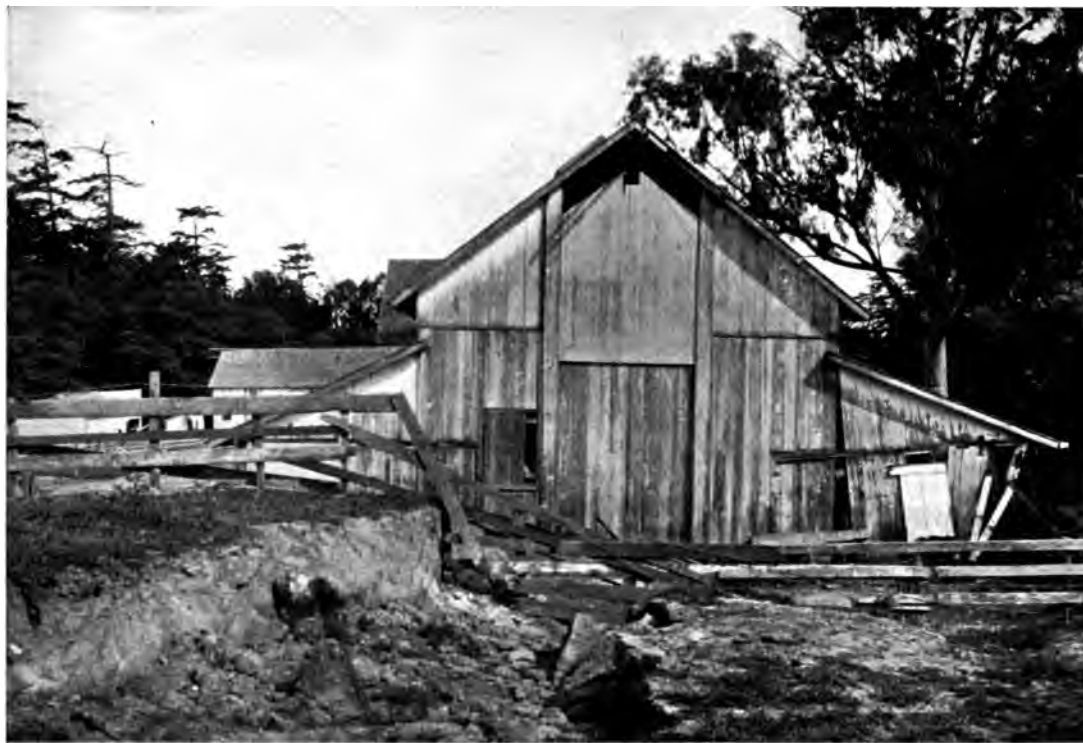
B. Fault-trace at the Skinner place, near Olema. Illustrating trench phase. G. K. G.

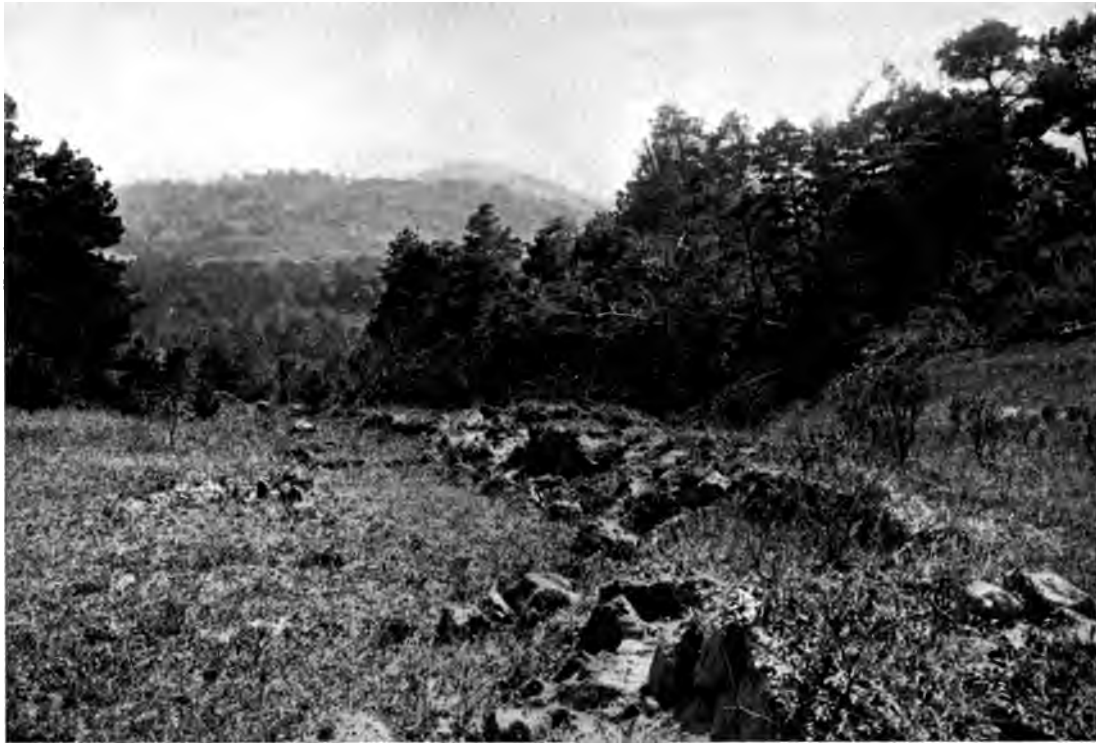
A. Branch of fault-trace on "north mesa" at Inverness. Looking southeast. G. K. G.

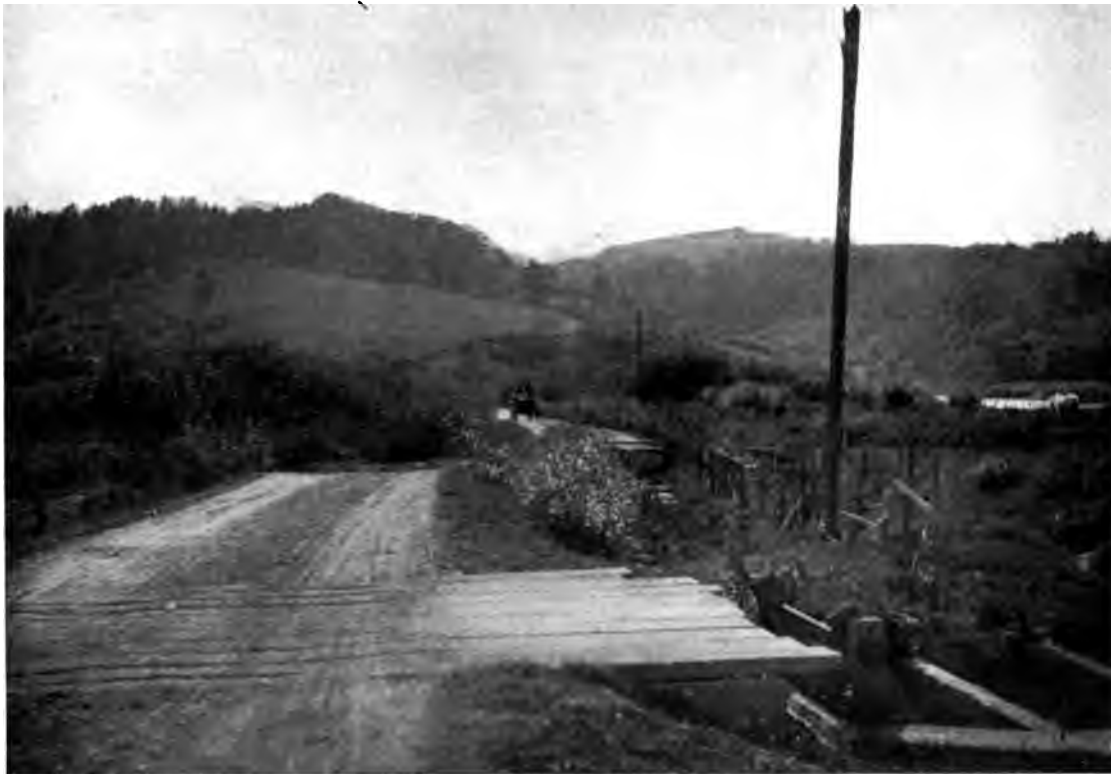
B. Road offset by fault. Looking southwest. G. K. G.

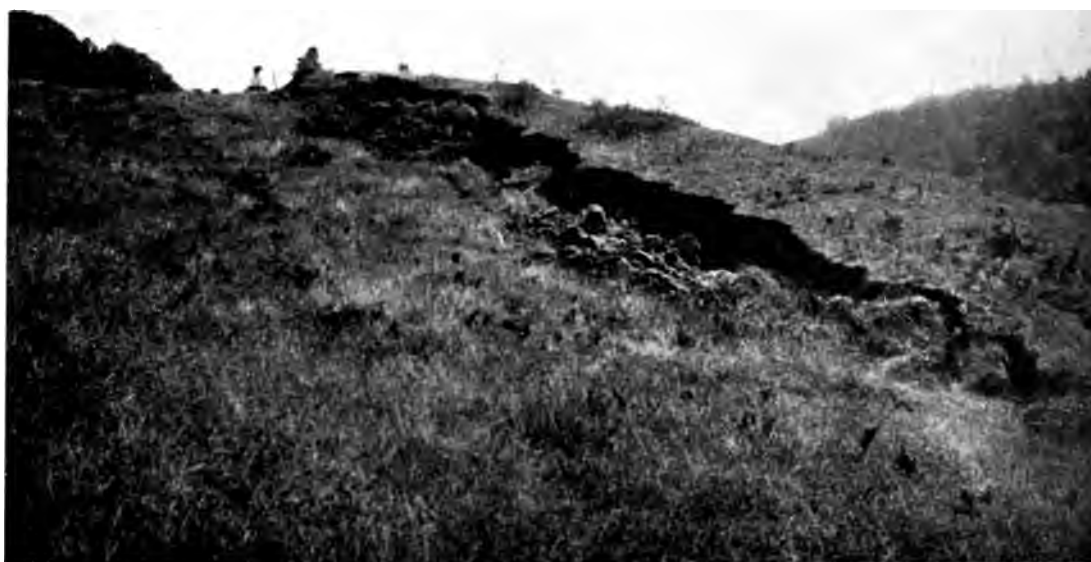
the northwest the horizontal throw caused an apparent vertical downthrow to the northeast. (Plate 48A.) Where the ground sloped toward the southeast an apparent vertical throw to the southwest was produced. Where the fault-trace followed a narrow sag interrupting the side slope of a ridge, the apparent vertical throw was on the side toward the ridge, as indicated in the diagram, fig. 6. (See also plates 10B and 48B.) The only unqualified record of vertical displacement is on Pepper Island in Bolinas Lagoon, where the mean of seven measurements shows a downthrow of 12 inches on the northeast side. The question whether the faulting along the plane of rupture was accompanied by the elevation or depression of large areas will be discussed in another place.

A. Fault-trace a mile northwest of Olema. Looking south. Appearance of vertical displacement largely due to combination of horizontal displacement with slope of ground. G. K. G.

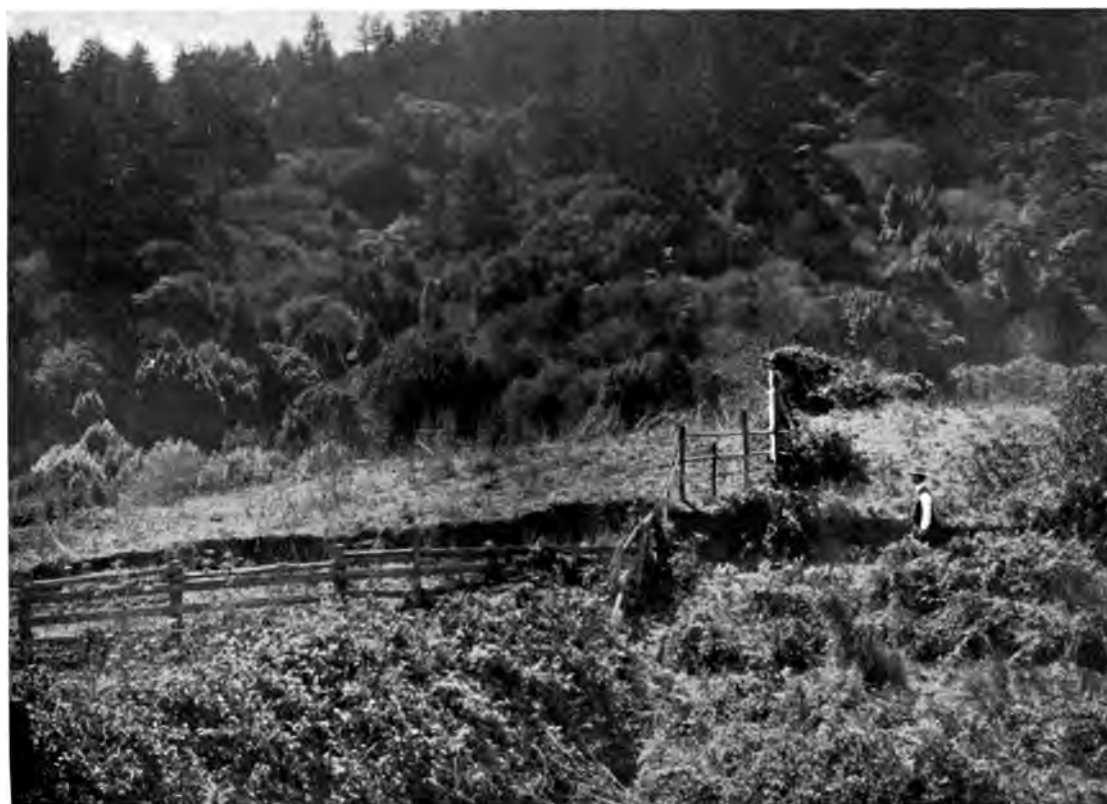
B. Fault-trace near Bondietti's ranch. Looking southwest. Shows vertical displacement bordering a sag. Horizontal displacement shown by fence, which had been repaired. G. K. G.

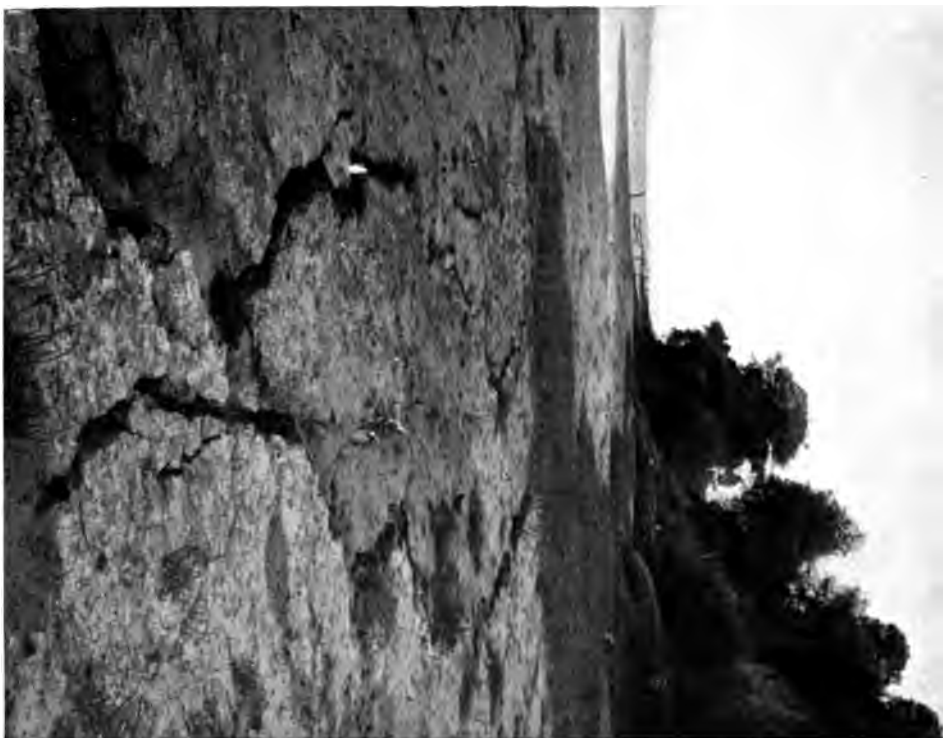
B. Cracks made by earthquake in tidal mud near head of Bolinas Lagoon. G. K. G.
